**Federal Aviation Administration**

**[Docket No. FAA-2012-1018; Directorate Identifier 2011-SW-052-AD;**

**Amendment 39-17204; AD 2012-19-09]**

**Airworthiness Directives; Eurocopter France Helicopters**

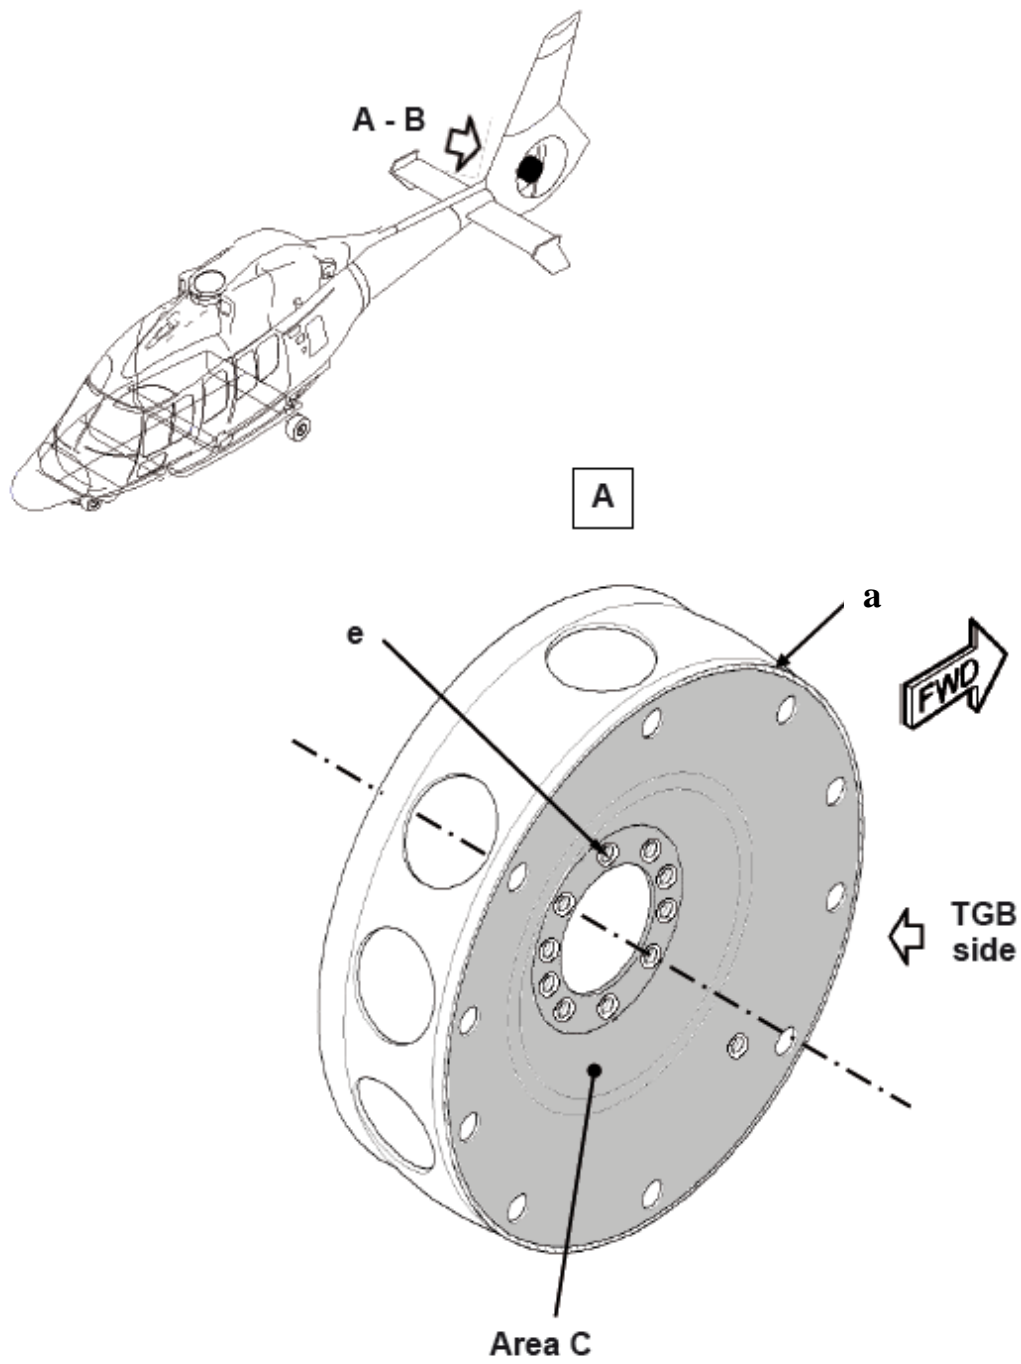
**Figure 1 to Paragraph (e)(1) TRH Hub**

(1) Within 55 hours time-in-service (TIS), and thereafter at intervals not to exceed 55 hours TIS, using a light, visually inspect the TRH for a crack in the entire area shown as Area C of the TRH (a) in Figure 1 to paragraph (e)(1) of this AD. The inspection area is on the tail gearbox (TGB) side of the TRH. The TGB is shown as (c) in Figures 2 and 3 to paragraph (e)(1) of this AD. You must pay particular attention to the area around the screws, shown as (e) in Figure 3 to paragraph (e)(1) of this AD, and the TRH between the lower part of the TGB and its fairing, shown as (d) in Figures 2 and 3 to paragraph (e)(1) of this AD, using details D and E of Figure 3 to paragraph (e)(1) of this AD. You must

(2) If there is a crack on the TRH, remove the TRH from service.

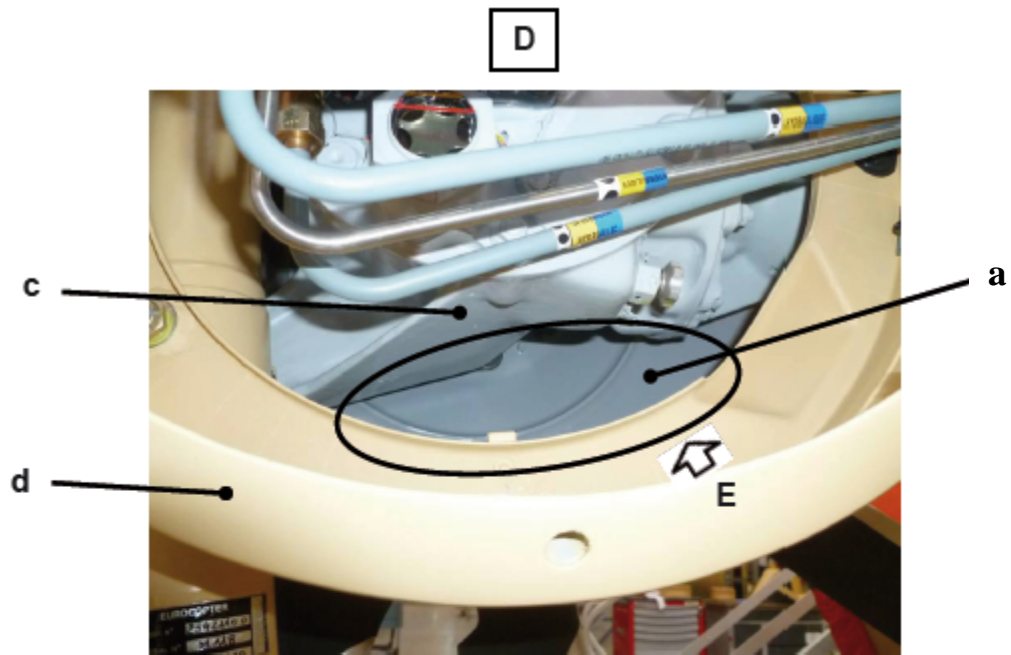
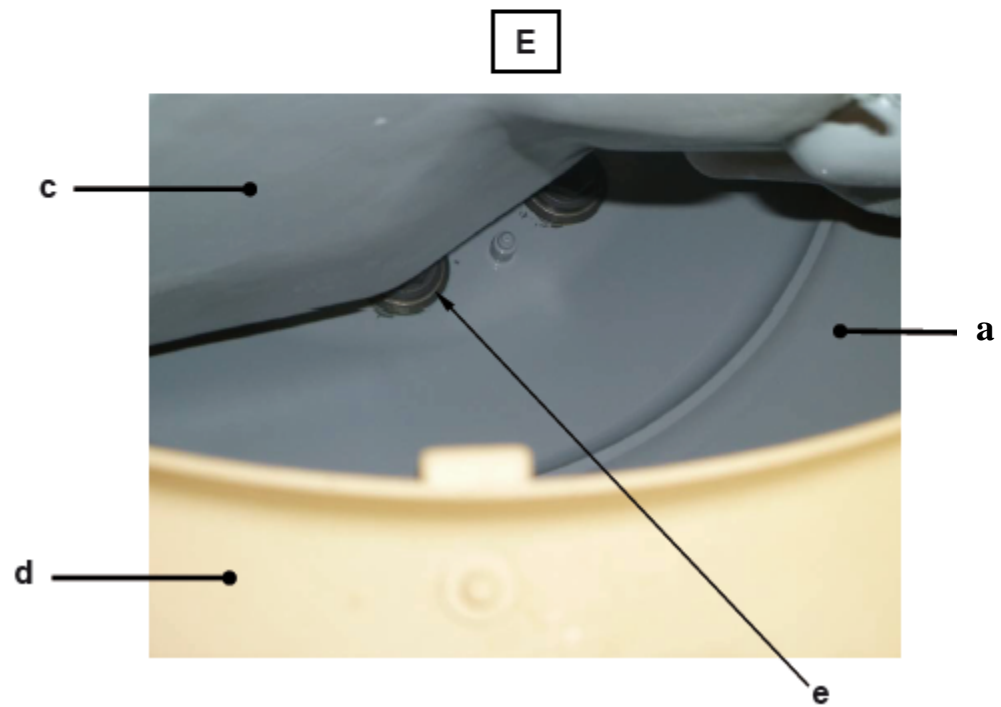
**Figure 3 to Paragraph (e)(1) Visual Inspection of Area C**

turn the tail rotor by hand to inspect the entire Area C.
